TWO LICK CREEK DAM

NDI No. Pa. - 285

**PHASE I INSPECTION REPORT  
NATIONAL DAM INSPECTION PROGRAM.**

GAI CONSULTANTS, INC.  
570 BEATTY ROAD  
MONROEVILLE, PENNSYLVANIA 15146

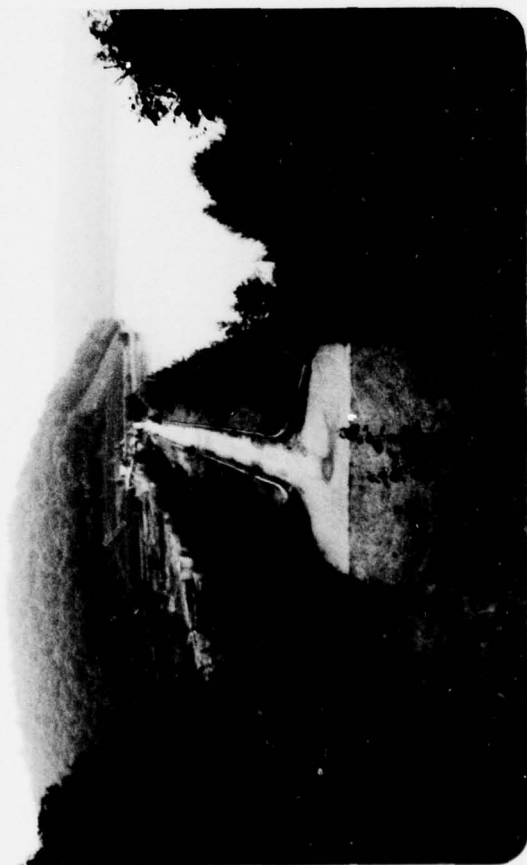
PHOTOGRAPH 3 View of the crest of Two Lick Creek Dam taken from the left abutment.

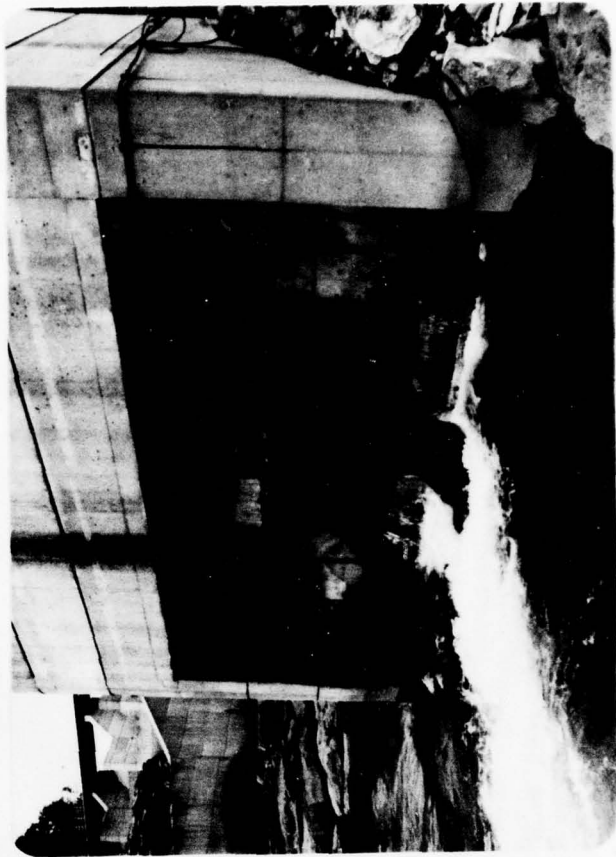
PHOTOGRAPH 8 View of the outlet end of the discharge tunnel at the Two Lick Creek facility.

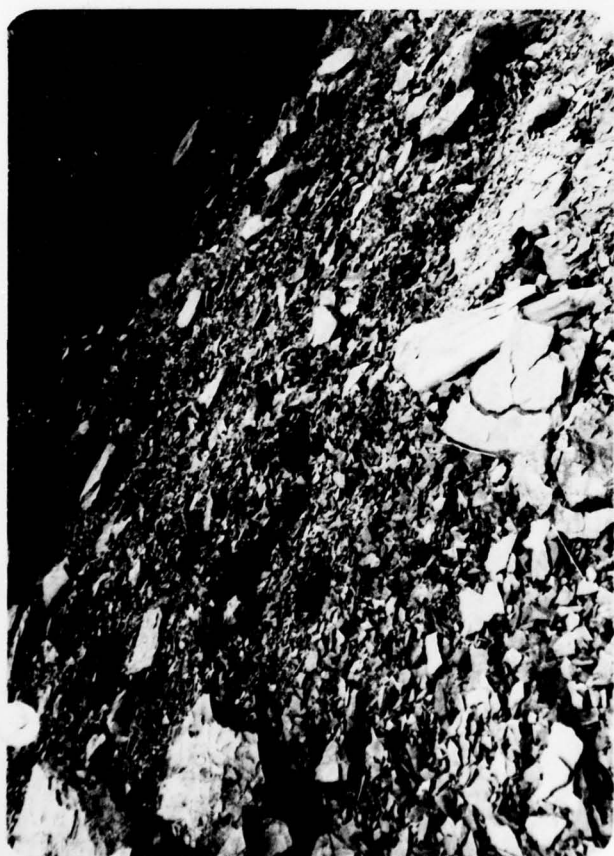
PHOTOGRAPH 9    Close-up view of materials comprising the downstream face of the earth section of Two Lick Creek Dam.

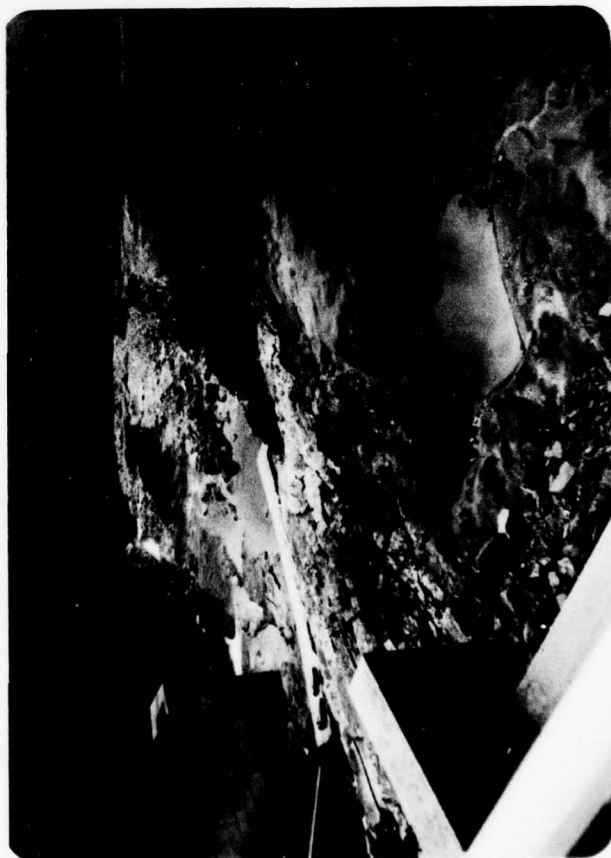
The portion of the downstream channel which is not in good condition is that area immediately beyond the emergency spillway (Bays 1, 2, and 3). Significant erosional damage occurred as a result of the July 1977, flood (see Photographs 11 and 12, Appendix D). The area, nevertheless, appears sound in spite of the damage. All concrete sections of the embankment remained intact.

PHOTOGRAPH 11    View of erosion in the rock channel at the outlet of the emergency spillway (foreground). The pool of water and earth dike mentioned in the previous photograph can be seen in the left background. Note the character of the valley just downstream of the dam.

d. The owner implement remedial measures to repair damage to the right abutment (emergency spillway outlet).

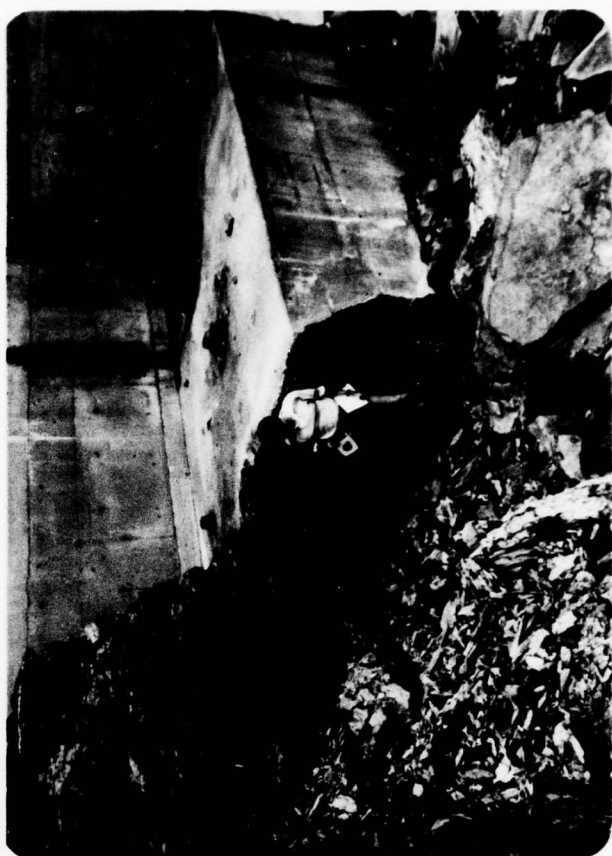
the facility has performed adequately in the past. During the flood of July 1977, the emergency spillway inadvertently discharged causing the damage to the right abutment which is visible today. The situation occurred because the automatic radial gate mechanism was wired to shut down when the gate opened two feet. Consequently, the water in the reservoir steadily rose until it discharged through the emergency spillway. The mechanism has since been repaired and the limiting device removed. The gates have been tested and reportedly are capable of opening fully.

PHOTOGRAPH 12    View of erosion damage at the intersection of the emergency spillway and the rock abutment. A coal seam was eroded out in this area.

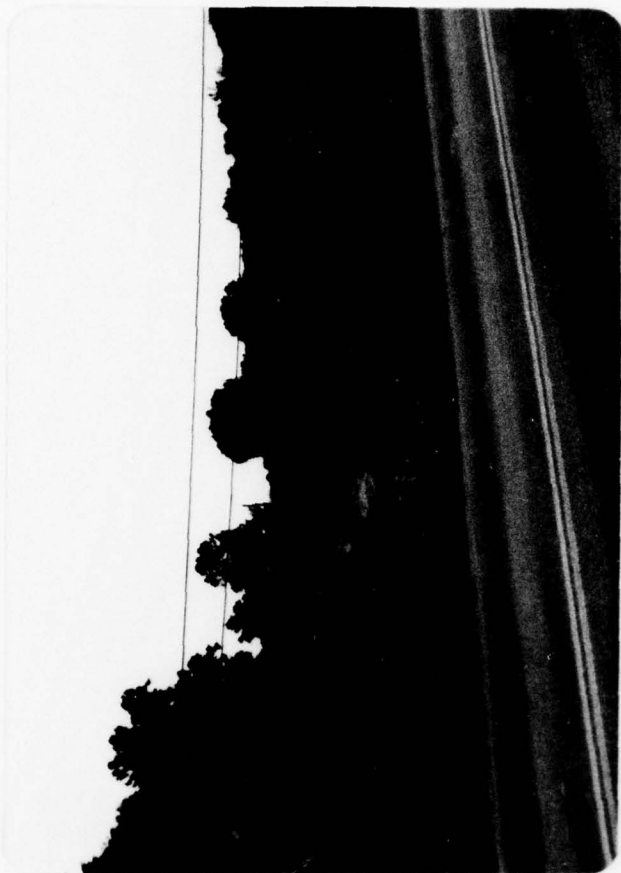
14

View of the first major obstruction downstream of Two Lick Creek Dam consisting of a concrete bridge over a secondary road approximately 3-1/2 miles downstream of the dam. About six homes are located adjacent to the creek at this point.
